## CATNIP II – Electronics Upgrades Part 2

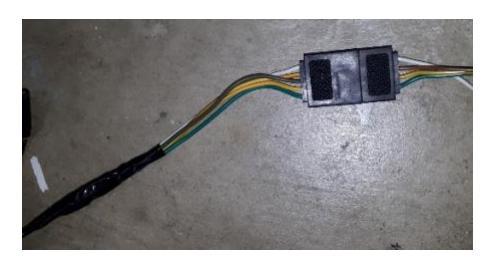
Part 1, covered preparations for installation of a Lowrance HDS9 sonar/chartplotter. The dash panel was fabricated and ready for installation. The connections between the HDS9 and the Standard Horizon GX2150 VHF radio were made with flat 4 trailer light connectors.

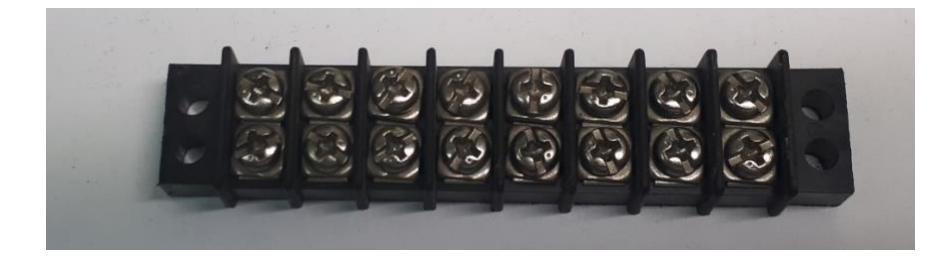
Both the Lowrance HDS9 and the Standard Horizon GX2150 have RS 422 connections. The HDS9 manual identifies the NMEA 0183 wires as RX\_A, RX\_B, TX\_A and TX\_B. The GX2150 manual identifies them as RX+, RX-, TX+ and TX-. Obviously the RX wires of the GX2150 connect to the TX wires of the HDS9 and vice versa but there are two ways to connect each pair. Some experimenting was needed. To make this easier, I purchased a terminal strip.

I connected the wires from the VHF radio to one side of the strip and the wires from the HDS 9 to the other side. It was easy to interchange the connections until everything worked. After a little experimenting, I discovered that

HDS 9	GX 2150
RX_A (orange)	TX+ (Gray)
RX_B (green)	TX- (Brown)
TX_A (yellow)	RX+ (Blue)
TX_B (blue)	RX- (Green)
